Wheel Hub Bearing Internal Thread Inspection and Sorting

App Note 1005

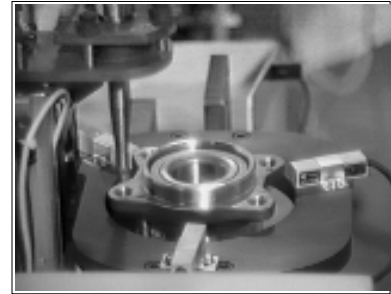
A leading producer of automotive wheel hub bearings needed to assure that four (4) threaded stud holes in a wheel hub was 100% free from thread defects. The four (4) threaded holes are not equally spaced along a bolt hole circle. Each hub was to be inspected in a fully automated machine placed in-line.

Automation Innovation coupled their proprietary Signature Analysis based Process Monitoring System to their Patent Pending Capacitive Thread Probes and created a fully automated machine which queues, inspects and sorts wheel hubs. All four (4) holes in each hub were inspected within the line's 12 second cycle time.

The automated system utilized a collet which rotated and picked up the hub from the proceeding station and placed it into the fingers of a gripper mounted on a rotary table. The hub was then clamped and rotated in a registration move utilizing proximity sensors to locate the threaded hole designated as hole number one. At this time a capacitive probe was moved in and out of the hole to inspect for any defects. The hub was rotated to each of the three (3) remaining

The signature analysis controller checked the signature obtained for each threaded hole and determines the quality of the threads. If all four (4) threaded holes are good, the hub was placed onto a packaging table. If one (1) or more of the holes were found to have a defect, the hub was placed into a rejection shut.
