ABS Housing Internal Thread Inspection

App Note 1004

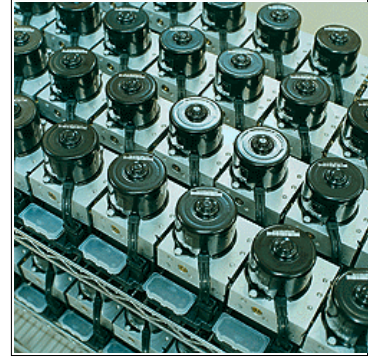
The systems were mounted into existing test stations along their automated assembly line. The parts were fixtured on part pallets which were registered by lift stations. The linear actuator moved the thread probes into the holes while the probe alignment devices orientated the probes to the centerline of each threaded hole.

The linear actuator removed the thread probes from the holes while the signature analysis controller checked the signature obtained from each threaded hole to determine thread quality.

A self-contained testing head was designed that included a linear actuator and mounting plate. The basic design was used in all systems.
